## VIBRATIONS DUE TO SOUND FIELDS IN A SENSITIVE BUILDING. DAMAGE CRITERION FOR THE NOISE LEVEL

The traditional buildings damage criteria for vibrations usually suppose ground borne vibration, although the limiting figures may also be used when vibrating mechanical equipments are installed on upper floors other than the ground floor. Also, noise and vibration limits are usually dealt with independent standards and regulations, as if noise and vibration were quite independent phenomena. In some cases, vibration of building elements produces noise. In the manner, sound or noise emitted inside buildings makes their partitions and structural elements vibrate. This paper relates a case study developed in a sensitive building made of steel and brick, a former power station now converted in a popular electricity museum. The study aimed the determination of such a noise level limit to be imposed on any music sound equipment operating inside this sensitive building larger room, in order to avoid damaging vibrations in the building facades. Also, vibration velocity limits were drawn from this study considering the damage limits established by current building vibrations standards and the ex

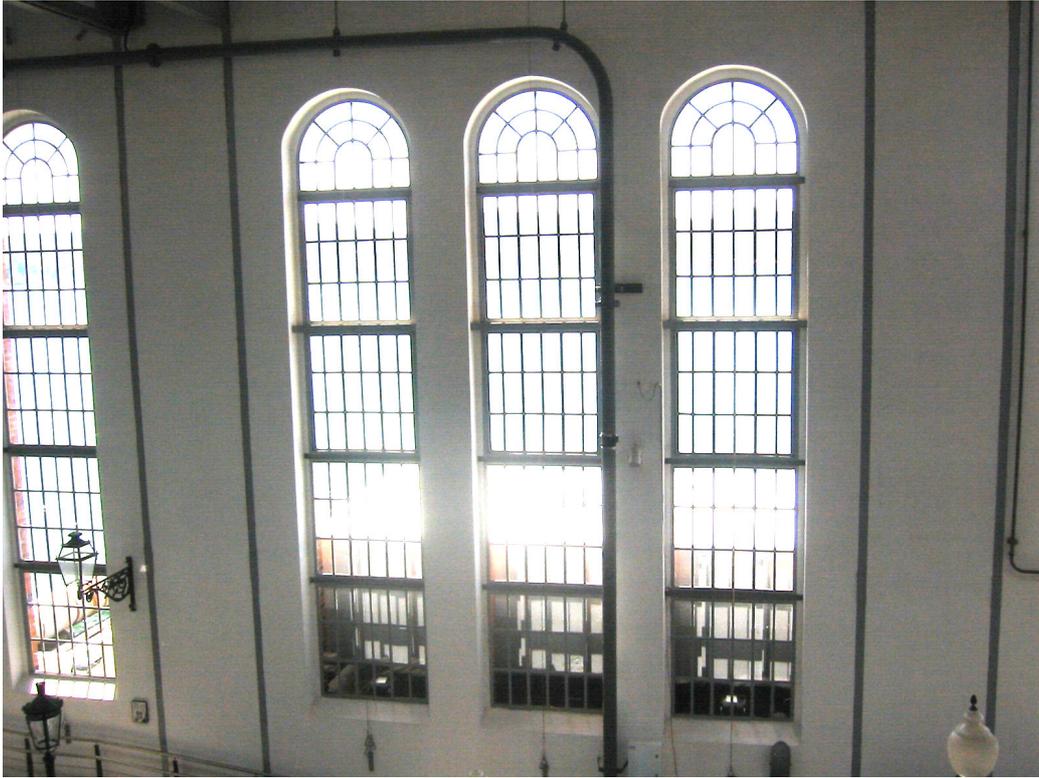
large windows, being the brick masonry built around the steel elements. Inside the building there are large spaces in which social and technical events take place. The walls surface are plaster finished (vd. figure 1). On masonry vertical elements, and between window openings, vertical cracks on the plaster were observed.

Figure 1 – Inside view of the western wall

A vertical crack, several *mm* wide, was detected on the plaster that covers one of the vertical elements between window openings. It may have resulted from the following accumulated causes:

- a) Vertical compression stress;
- b) Thermal stresses - the glass windows have steel frames and the building western side is cooler in the morning and hotter in the afternoon on sunny days;
- c) Atmospheric humidity (from rain and riverside damp) that have entered into the masonry causing expanded rust in the imbedded steel beams, forcing consequently the bricks to separate away; and,
- d) Some previous vibration.

Also, the structure condition, especially where plaster cracks show, must be monitored.

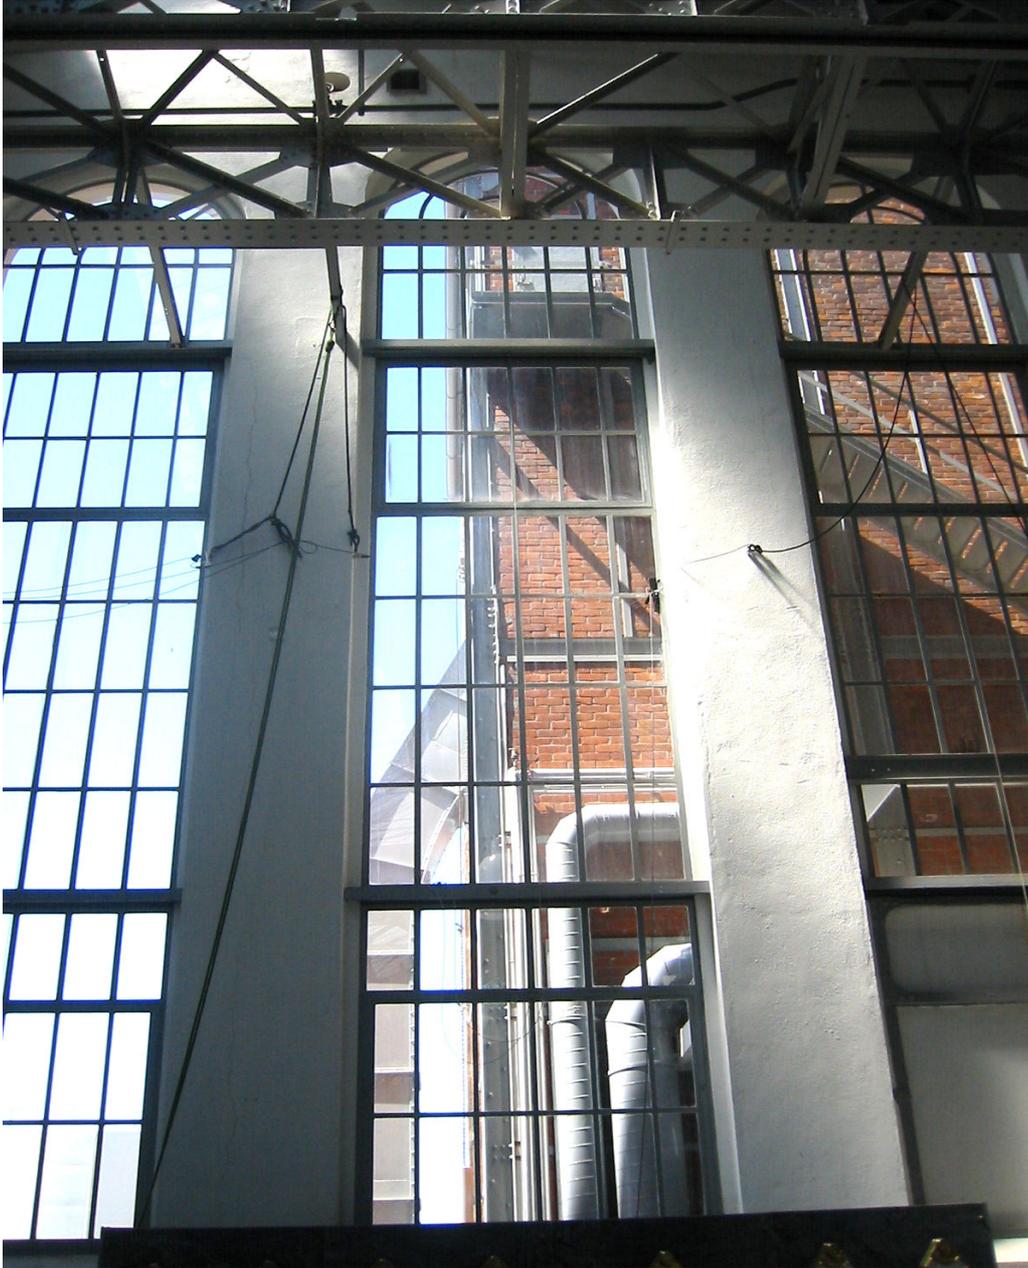
Figure 2 – Velocity transducers on the western wall

Velocity transducers were glued to the walls to measure the normal component of the vibration velocity. Sound meters were used to measure and analyse the sound power in the 1/3 of octave frequency bands.

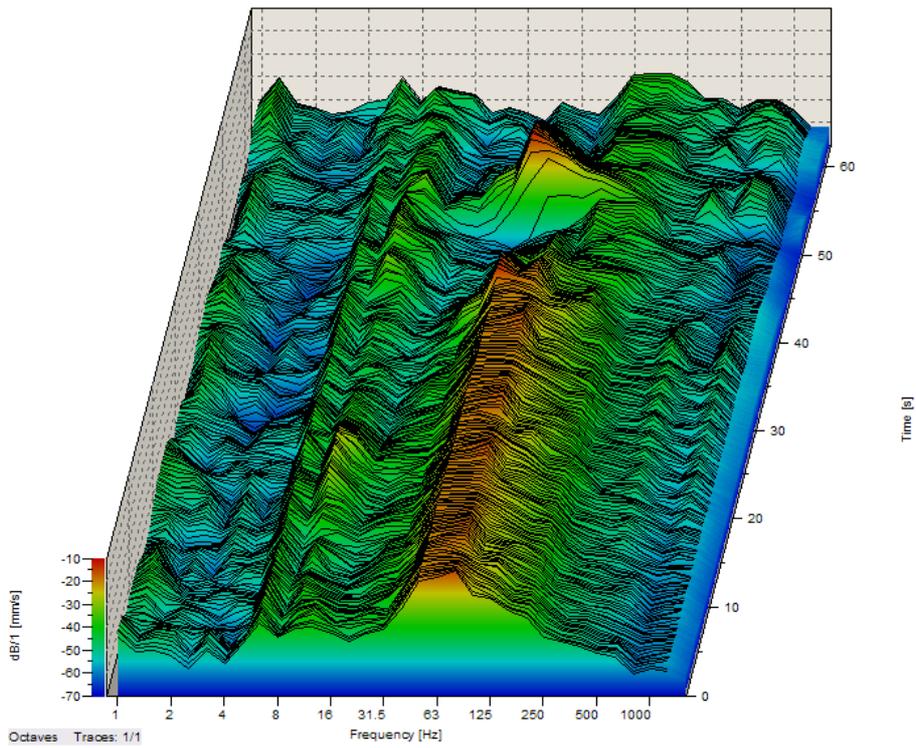
Next figures show some of the vibration spectra of the recorded vibration velocities. Low frequency (6,3 e 10 Hz , sometimes 12,5) components, were also found in the ambient vibration spectrum. They could be assumed as natural frequencies of the building and walls (probably of the vertical element between window openings); note that frequency figures are the bands central frequency values.

Figure 3 – vibration velocity spectrum as function of time (case D, point 2)

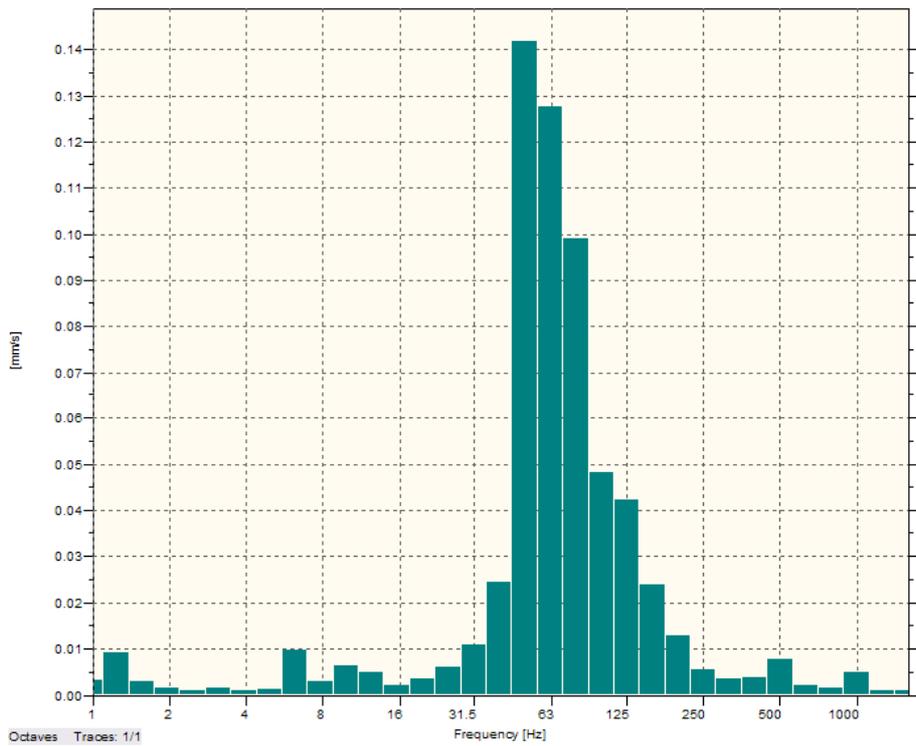
Significant components in the frequency bands of 63 Hz and adjacent bands (50 e 80 Hz) are also due to the significant components of the input in the same frequencies, both of the pink noise and of the music. The sound equipment transfer function cuts the inputs at 20 Hz and below.

Figure 4 – Vibration velocity spectrum (case D, point 2)

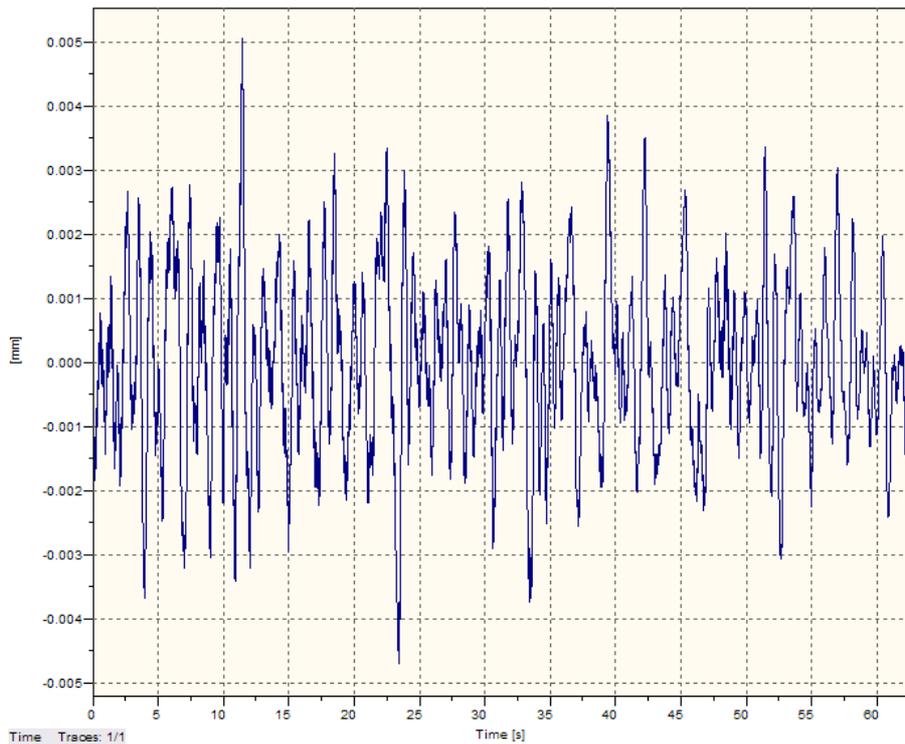
Figure 5 – Displacement in the most significant existing crack (case D, point 2)
